Service Action: Inspect Front Driveshaft

E70 (X5)

E71 (X6)

E72 (X6 ActiveHybrid)

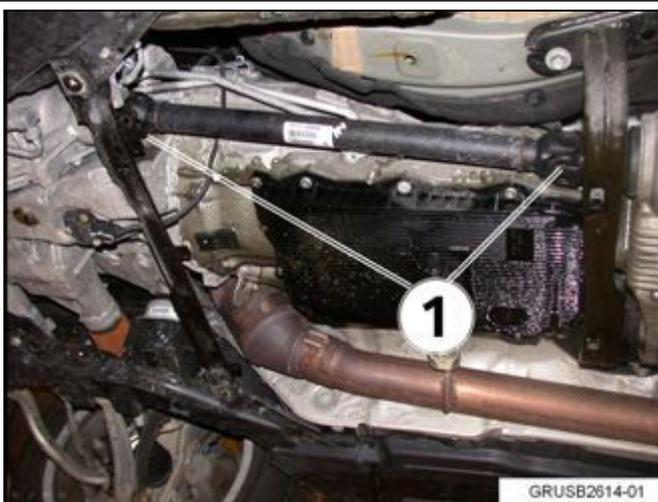
Check the universal joints in the front driveshaft for radial play (1).
Note: The E72 will need to have the reinforcement plate removed to check the driveshaft U-joints. Refer to Repair Instruction 31 10 010, "Removing and installing/replacing reinforcement plate."

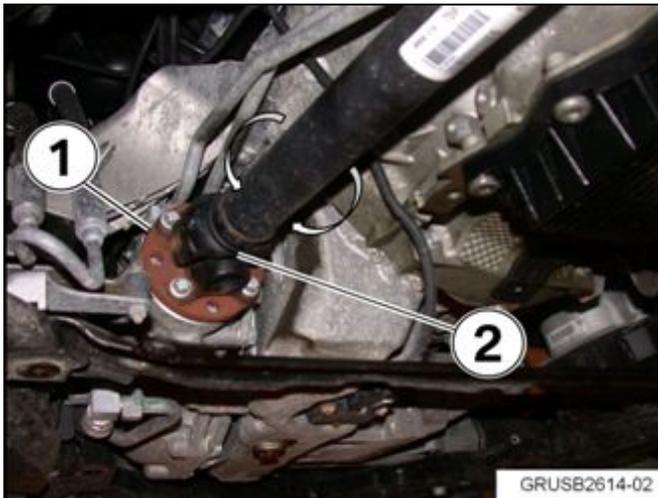
1. Checking the front U-joint:

Hold the input flange (1) on the front differential and check for radial play in the U-joint (2). There should be no excessive play.

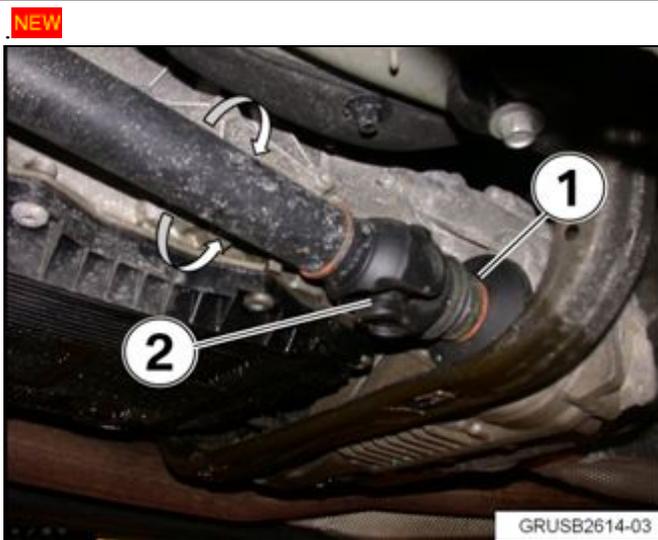
2. Checking the rear U-joint:

Hold the output flange (1) on the transfer case and check for radial play in the U-joint (2). There should be no excessive play.

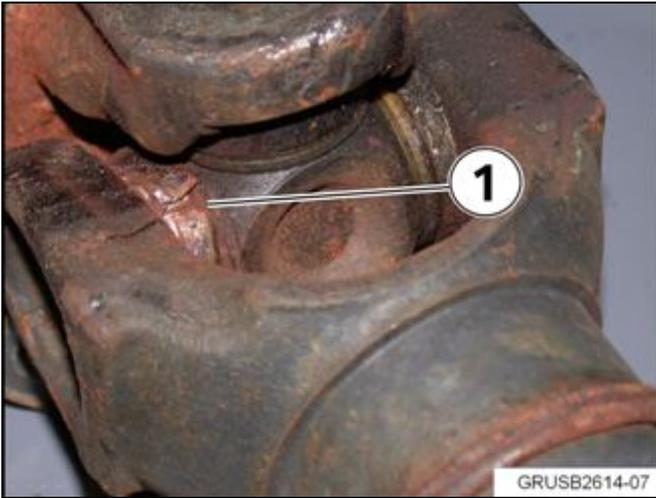
1. **NEW** There should be no cracking or damage at the bearing seals (1).

NEW If any of the above conditions are present, replace the driveshaft. Refer to Repair Instruction 26 20 000, "Removing and installing front propeller shaft as of 4/2010."

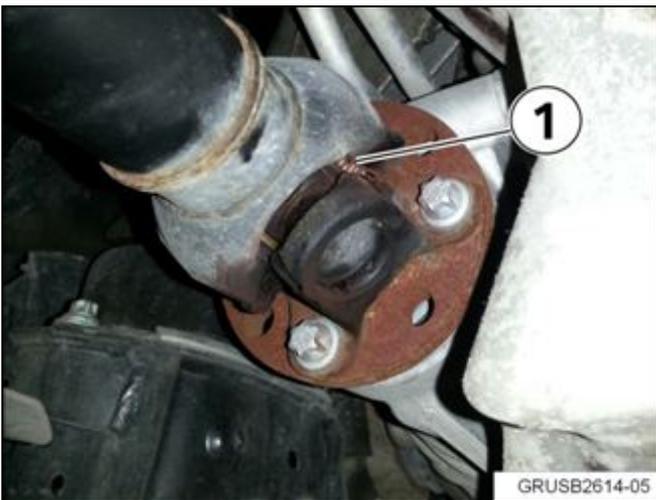
2. **NEW** There should be no exposed needle bearings (1).

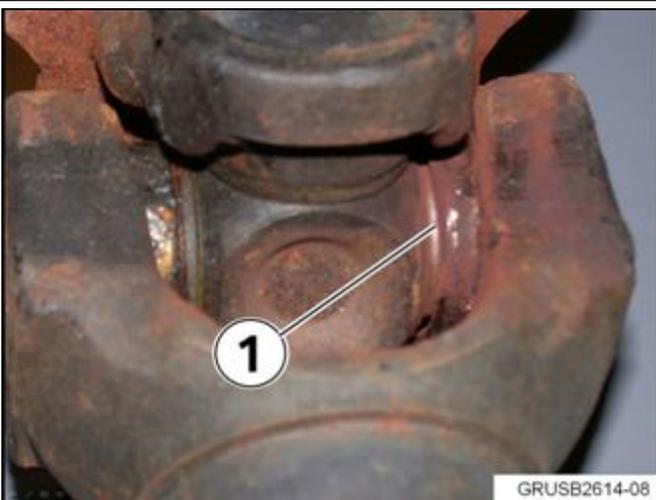
3. **NEW** There should be no excessive rust at the bearing seals (1). Note: There will be rust buildup on the driveshaft and mounting flange on some driveshafts. This rust is normal. Only excessive rust on the bearing seals indicates the seal may fail.

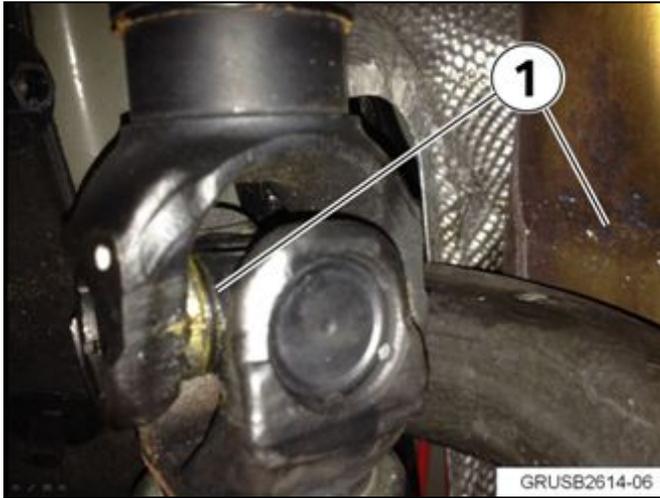
4. **NEW** Also check for excessive grease marks on the surfaces of surrounding components around the U-joints and for excessive grease released out of the bearing seals (1).
