Service Action: Inspect Front Driveshaft

E70 (X5)

E71 (X6)

E72 (X6 ActiveHybrid)

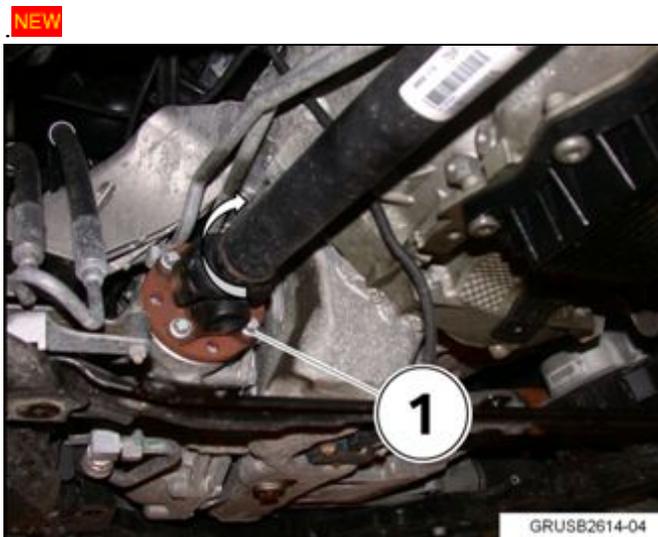
2. Checking the rear U-joint:

Hold the output flange (1) on the transfer case and check for radial play in the U-joint (2). There should be no excessive play.

NEW If any of the above conditions are present, replace the driveshaft. Refer to Repair Instruction 26 20 000, "Removing and installing front propeller shaft as of 4/2010."
